# TOURRIDER

## Perimeter Light - Condensation

## DAIMLER TRUCK

### Daimler Buses

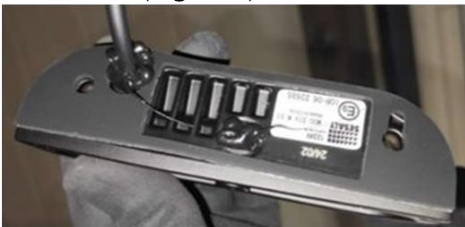
- Cause #2: Excessive Sealant: Too much Sika sealant applied between the metal guard and the coach body can block the membrane. (Figure 2)

Figure 2: Incorrect Installation. The vents for the condensation membrane are blocked by excess sealant.

- Apply sealant ONLY to the top and sides of the bracket that will contact the coach body. (Figure 4)

- Use only enough sealant to create a good seal.
- After placing the bracket, immediately clean any excess sealant that may have squeezed out near the membrane area.

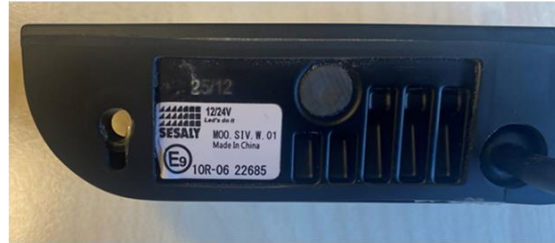
Figure 3: Note the clear, unobstructed membrane area.

When installing a new metal light guard, proper application of Sika sealant is critical to prevent blockage.

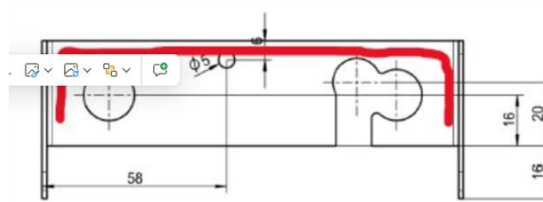
Figure 4: Correct Sealant Application Area. Apply sealant only along the top and sides of the bracket as shown in red.

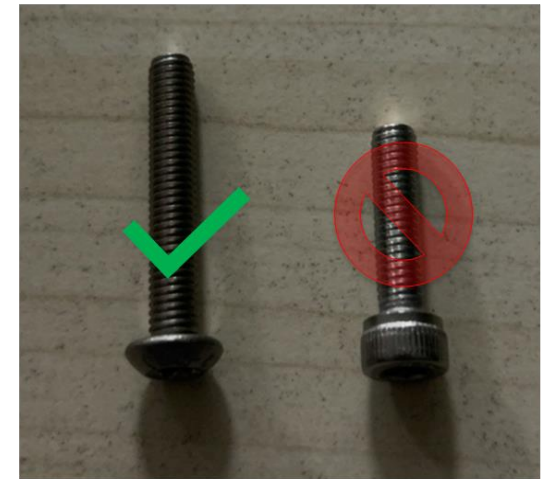
Figure 5: Correct vs. Incorrect Hardware. The correct, longer screw (left) must be used. The shorter screw shipped with replacement lights (right) is incorrect.

- The mounting screws shipped with replacement perimeter lights have been identified as being too short.
- ALWAYS reuse the original, longer screws when replacing a light.
- If original screws are unavailable, new screws can be ordered using part number **A.013.990.33.04**
